# The Ontogeny and Mitigation of Gully Erosion in the Coastal Plain Sands of Uyo, Southeastern Nigeria: A Comparative Field Assessment

*Department of Geography and Natural Resources Management, University of Uyo, Uyo*

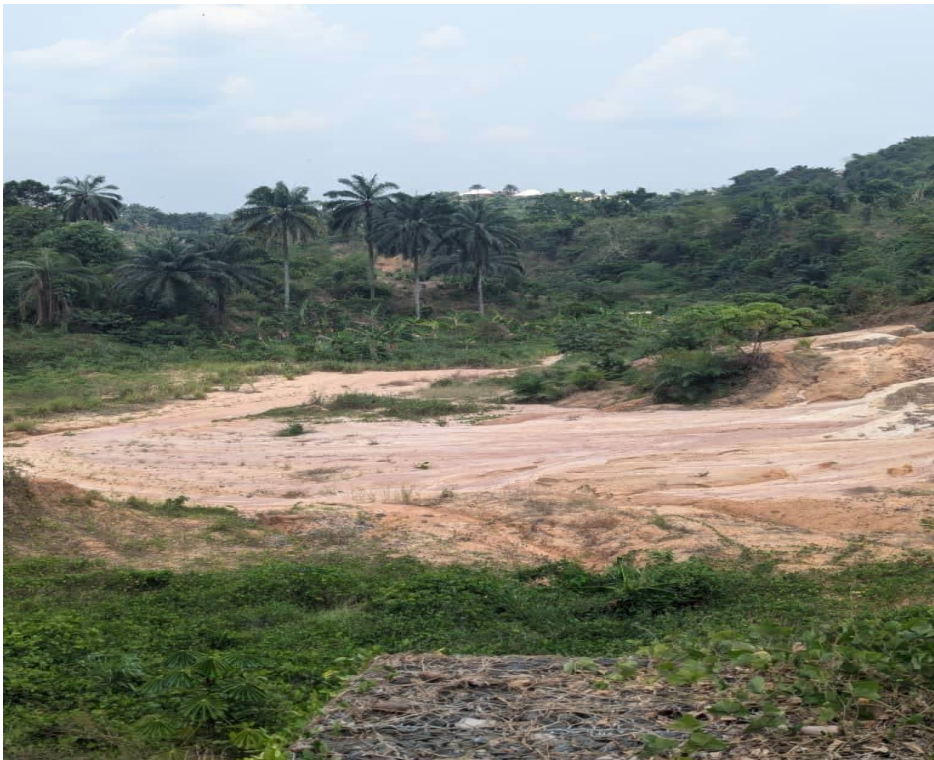
Figure 2: Anthropogenic Pressure at School of Nursing Gullies

More concerning is that 40.0% of measures are poorly effective, indicating frequent failure or rapid degradation of interventions. This points to issues such as inadequate design standards, poor construction quality, insufficient maintenance, misalignment with site conditions (e.g., sandy soils, high flows), and weak institutional follow-through. It may also reflect implementing single solutions where combined (engineering + biological + land management) approaches are required (see figure 2-6).

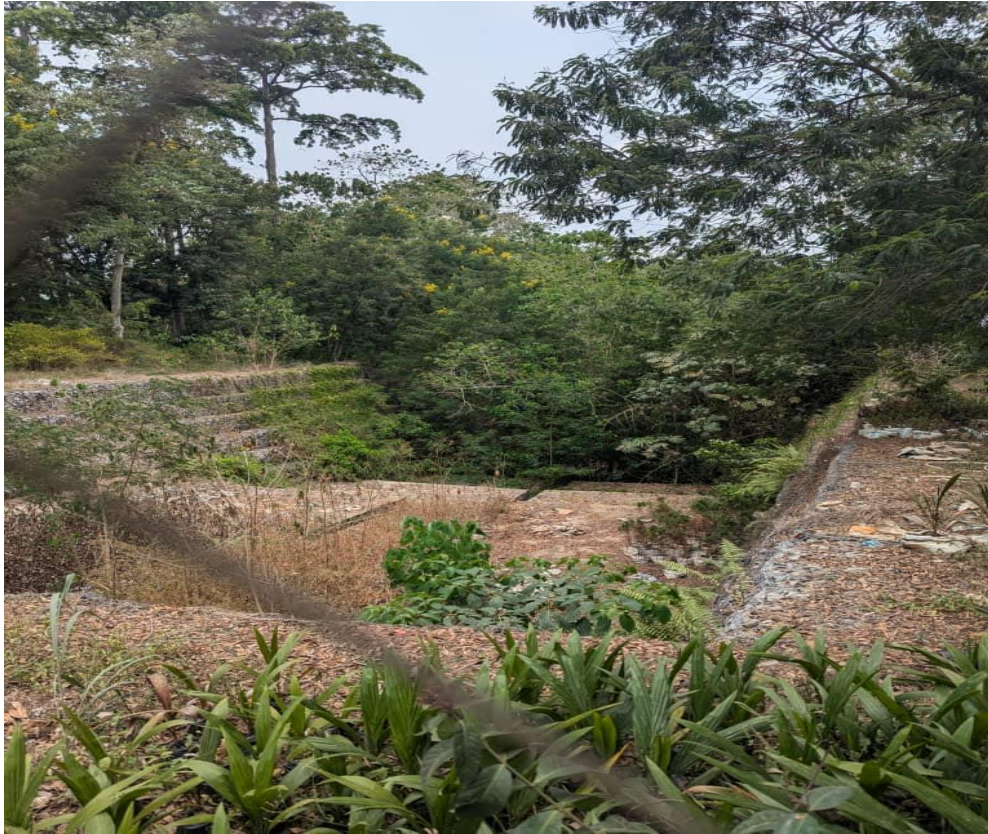
**Figure 3: Gully by UNIUYO Main Campus – Engineering Structures**

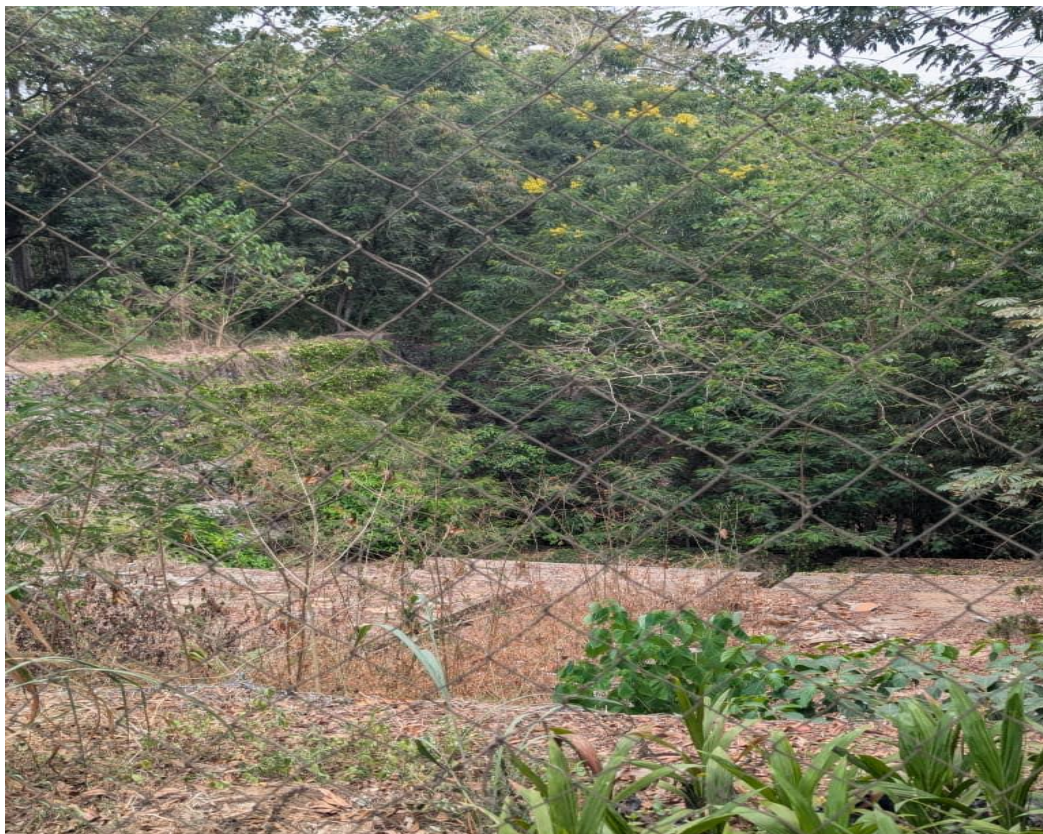
**Figure 4: Wire Fencing as a management approach**

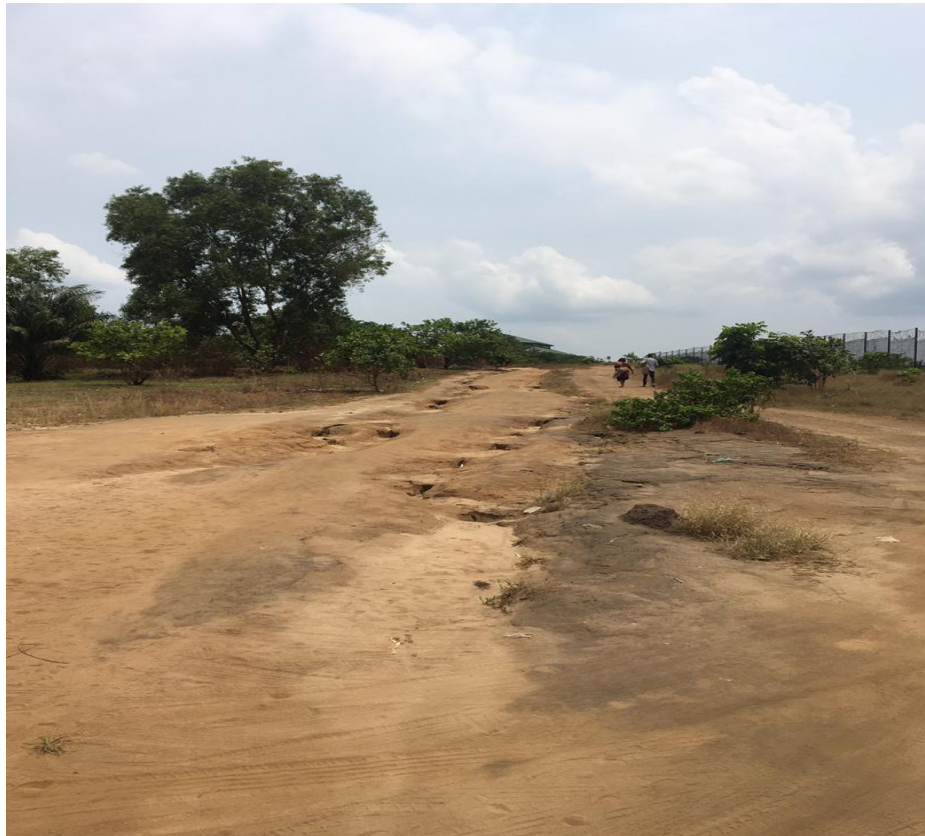
**Figure 5: Rill Erosion by UNIUYO Post Graduate School**

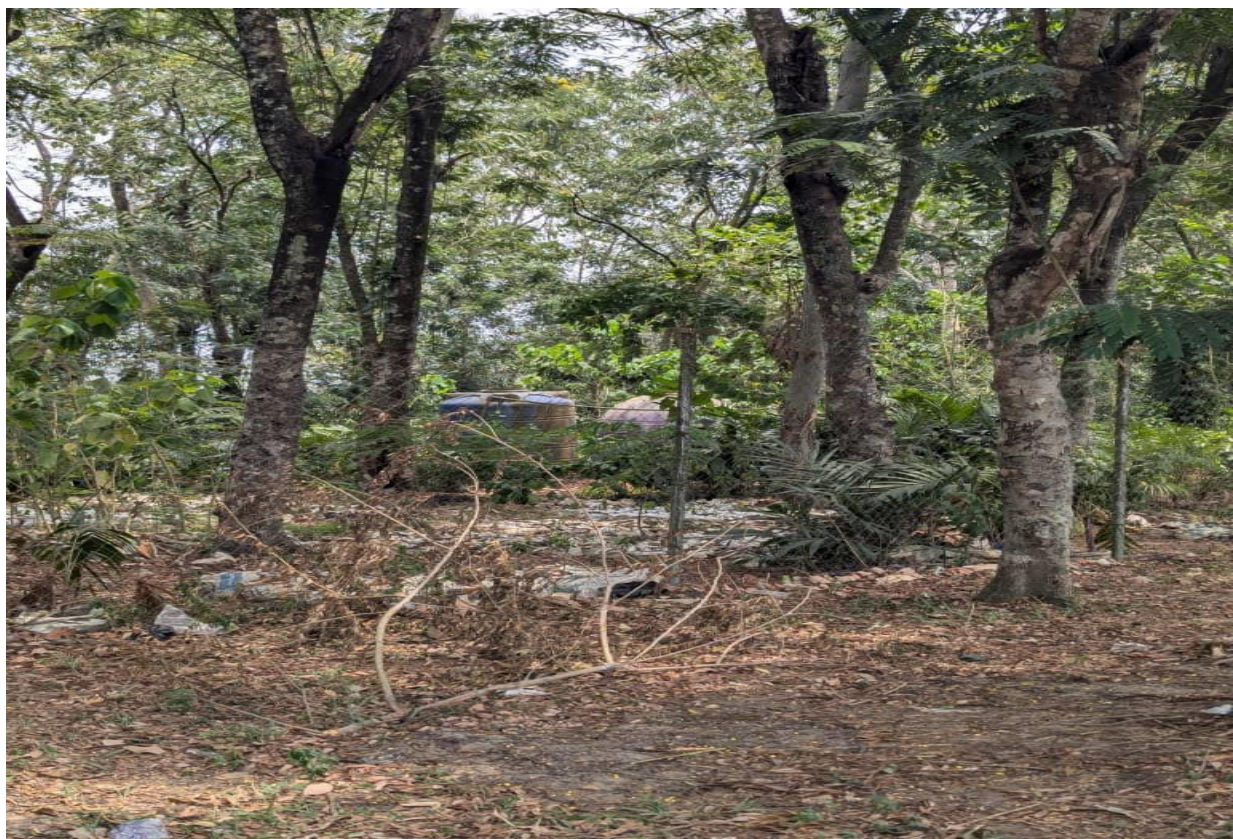
**Figure 6: Tree Planting as a buffer against gully provocation**

Biological measures (27.4%), including vegetation planting and afforestation, are moderately adopted. This indicates some recognition of the importance of eco-based solutions, which improve soil cohesion, reduce raindrop impact, and enhance infiltration. However, their lower proportion compared to engineering methods suggests that nature-based strategies are underutilized, despite their long-term sustainability benefits.
